Service Letter No. 2018-0001
January 1, 2018

Subject: Shut-off Valve Torque Has Increased

Models Affected: All International Maxxforce DT466E, DT570/N9 and HT570/N10 engines equipped with the Jacobs' Model 5313 & 5326 Bleeder Brakes

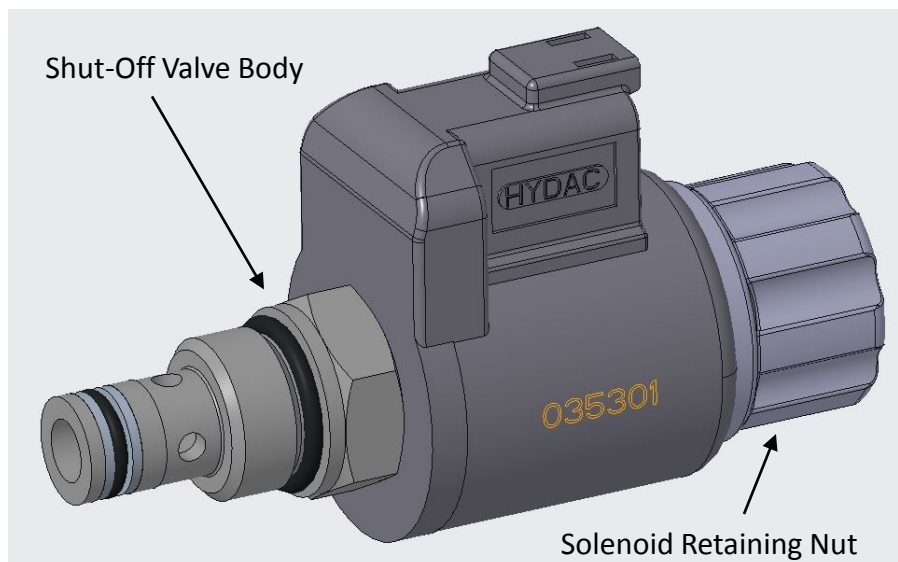
In rare cases, it has been reported that the shut-off valve has been found loose. This may cause a hard start/no start condition.

Remove the shut-off valve from the brake rail and inspect the condition of the seals. If the seals are damaged, replace the valve. If the seals are found to be in good condition, reinstall the shut-off valve into the brake rail and torque the valve body to the new torque of 35 lb.-ft. and the solenoid retaining nut to 4 lb.-ft. Over torquing may cause damage, resulting in loss of shut-off valve function.
