Service Letter No. 410
October, 1994

SUBJECT: Anti-Rotation Pin Installation

MODELS AFFECTED: C317/C317A

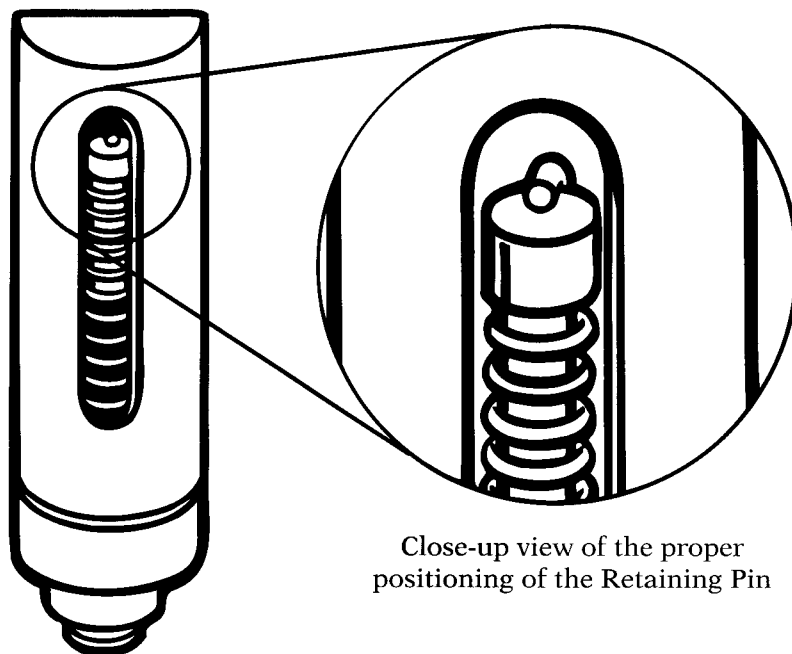
Jacobs has seen several instances of improperly installed Anti-Rotation Pins, P/N 015814. Failure to properly install the pin so that it retains the end of the spring seat (and **not** through the coils) may result in engine damage.

Close-up view of the proper
positioning of the Retaining Pin

Note in the illustration below that the retaining pin (used to hold the spring and seat in place prior to installing the piston assembly in the housing) must be over the spring seat. After the piston is installed in the housing and the retaining pin has been replaced by the anti-rotation pin, make sure that the pin is seated properly by pulling and releasing the piston and noting the amount of protrusion of the piston out of the housing compared to the other pistons. An improperly seated anti-rotation pin will cause the piston to protrude approximately an extra 1/4" more than one that is properly seated.
