# THERE IS A **DIFFERENCE**

## GENUINE CUMMINS PARTS

# THE GENUINE DIFFERENCE, MAGNIFIED.

## NON-GENUINE PUT TO THE TEST

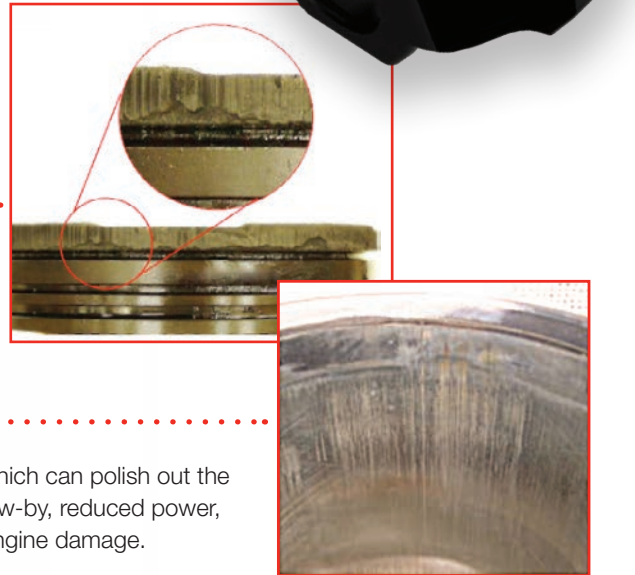
- Utilises the old, non-APR (Anti-Polishing Ring) design

**RISKS:** Carbon buildup on top land of the piston which can polish out cylinder liner cross-hatch .....

Using the old, non-APR design can lead to the buildup of carbon which can polish out the cylinder liner cross-hatch, leading to increased oil consumption, blow-by, reduced power, progressive damage to the aftertreatment, and even catastrophic engine damage.

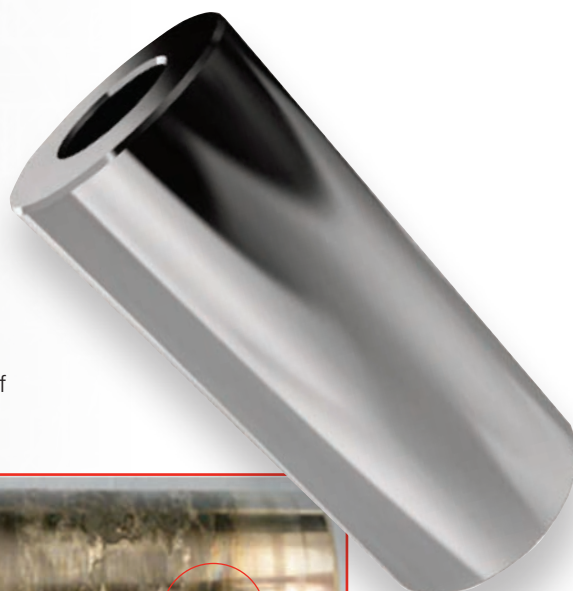
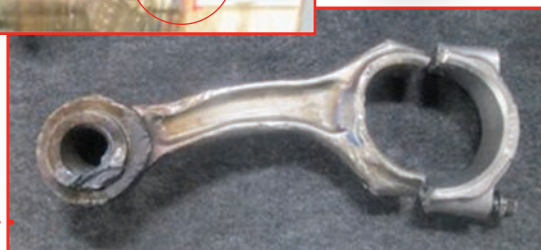
- Inner and outer diameter do not meet specification

- Material does not meet specification

Piston pin joint seizure can result in severe catastrophic engine failure when the connecting rod is no longer able to move freely in relation to the piston.

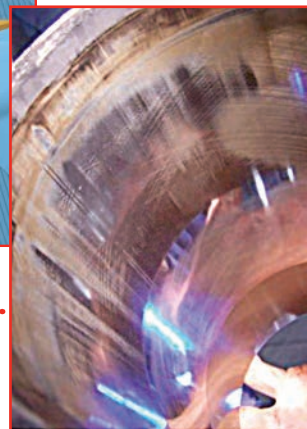
- Utilises the old, non-APR (Anti-Polishing Ring) design .....

- Case depth of inner diameter is above specification

- Microstructure of inner diameter does not meet specification

Cylinder liner failure can result in inefficient combustion, reduced power, excessive wear of related parts such as piston rings, increased oil consumption, blow-by and progressive damage to aftertreatment.

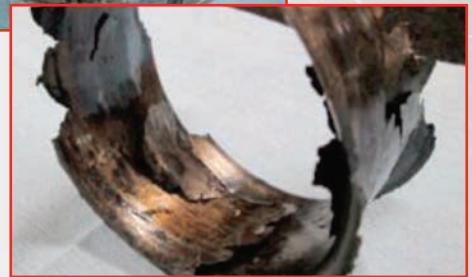
- Missing critical oiling grooves  
**RISKS:** Improper oiling to bearing; potential for thrust bearing failure .....

- Does not meet specification for material requirements or lining thickness  
**RISKS:** Robustness of material is severely compromised; high potential for delamination

Delamination of bearing layers, corrosion and the absence of critical oiling grooves can lead to spun bearings which result in severe catastrophic engine damage.

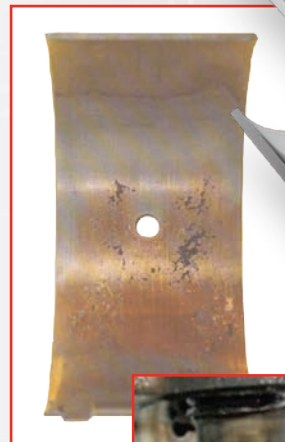
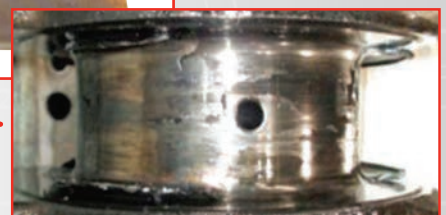
- Outer diameter does not meet specification  
**RISKS:** Interference with mating parts

- Surface damage observed during stereoscopic analysis .....
- Chemistry composition does not meet specification  
**RISKS:** Adversely affects the seizure, conformability and debris resistance of material; robustness is severely compromised; delamination related failures

Delamination of bearing layers and corrosion can lead to spun bearings which result in severe catastrophic engine damage.

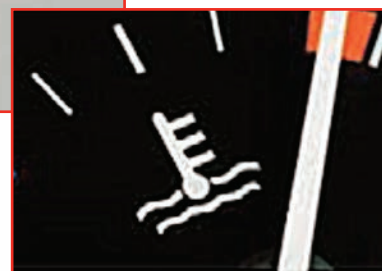
- Fluid passage hole is incorrectly sized .....
  - Missing fluid passage hole .....
- RISKS:** Fluid flow obstruction resulting in improper coolant and oil flow; major engine damage

Fluid flow obstructions can result in major catastrophic engine damage due to inadequate cooling or oil flow restriction.

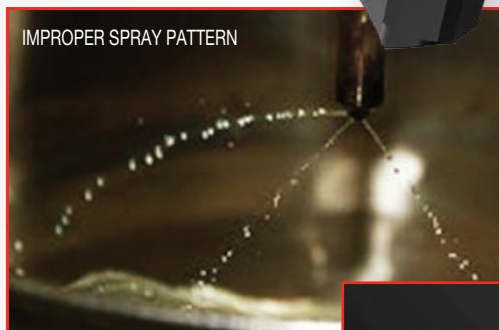
- Torque from solenoid and retainer below specification  
**RISKS:** Fuel carryover to engine oil; spun bearings
- Needle valve pop-off pressure below specification  
**RISKS:** Reduced injector fuel flow; Low engine power and improper combustion
- Solenoid closing time below specification  
**RISKS:** Shortened injector life; injection timing issues
- Barrel flow above specification  
**RISKS:** Improper combustion; injection timing issues

Improper injector function can result in inefficient combustion, misfire, reduced power and progressive damage to the power cylinder or downstream components such as aftertreatment.
