Service Letter No. 442 July, 1995

SUBJECT: External Oil Supply Hose

MODELS AFFECTED: 404D and 411

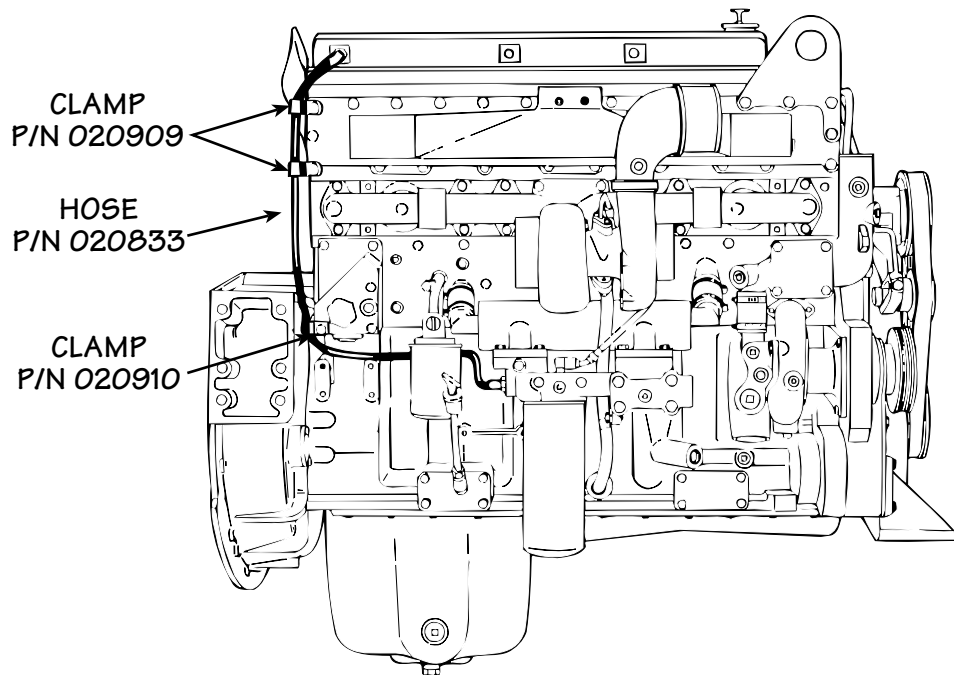
Effective with shipments beginning July 17, 1995, the External Oil Supply Hose Assembly, P/N 018198, will be replaced with a new External Oil Supply Hose Assembly, P/N 020833. The new hose will be secured by the following clamps:

Clamp, P/N 020910 (quantity: 1) replaces Clamp, P/N 018470 (quantity: 1)

Clamp, P/N 020909 (quantity: 2) replaces Clamp, P/N 017879 (quantity: 2)

The location of these clamps and the oil supply hose routing is illustrated below:

The changes listed above are product improvements and are not subject to campaign. Please note that it is acceptable to use up inventory of the current hose as long as it is routed and secured with the proper clamps as noted in Service Letter No. 432. The existing clamps cannot be used with the new hose, nor can the existing hose be used with the new style clamps.
